# A BRIEF HISTORY OF DHE MATERIALS

Gene Culver  
Geo-Heat Center

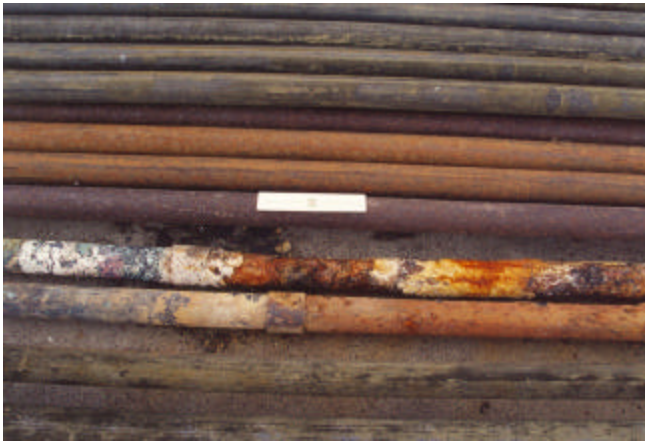
Before long DHEs were being installed in other wells and their success in reducing problems in the aboveground parts of the system led to increased drilling of the resource (Figure 1). In non-artesian wells, corrosion near the water level was the major problem; although, failures do occur at other locations (Figures 2 and 3). Non-artesian DHE life was generally on the order 10 - 15 years—in artesian wells, about twice as long.

**Figure 2.** *Corrosion and failure of a residential DHE at the air/water interface.*

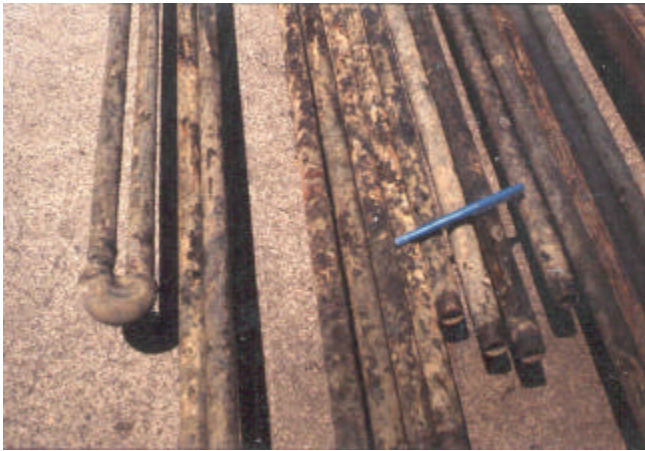
**Figure 3.** *Corrosion and pitting of DHE replaced in 1974. Note the Reverse loop at the bottom of the heat exchanger.*

All of the above failed to address the problem of corrosion well below the water level. This typically occurs at the very bottom of the DHE or where the DHE either contacts or is very near the well wall. It appears to be more pronounced in wells only partially cased. Wells are rarely drilled perfectly straight. DHEs never hang perfectly straight because of slight differences in pipe length, coupling tightening and the fact that the hot leg thermally expands more than the cold leg. One leg usually spirals around the other.
